Total Land Subsidence in the Ranegras Valley, La Paz County
 Based on Radarsat-2 Satellite Interferometric Synthetic Aperture Radar (InSAR) Data
 Time Period of Analysis: 2.0 Years 03/30/2016 To 03/20/2018

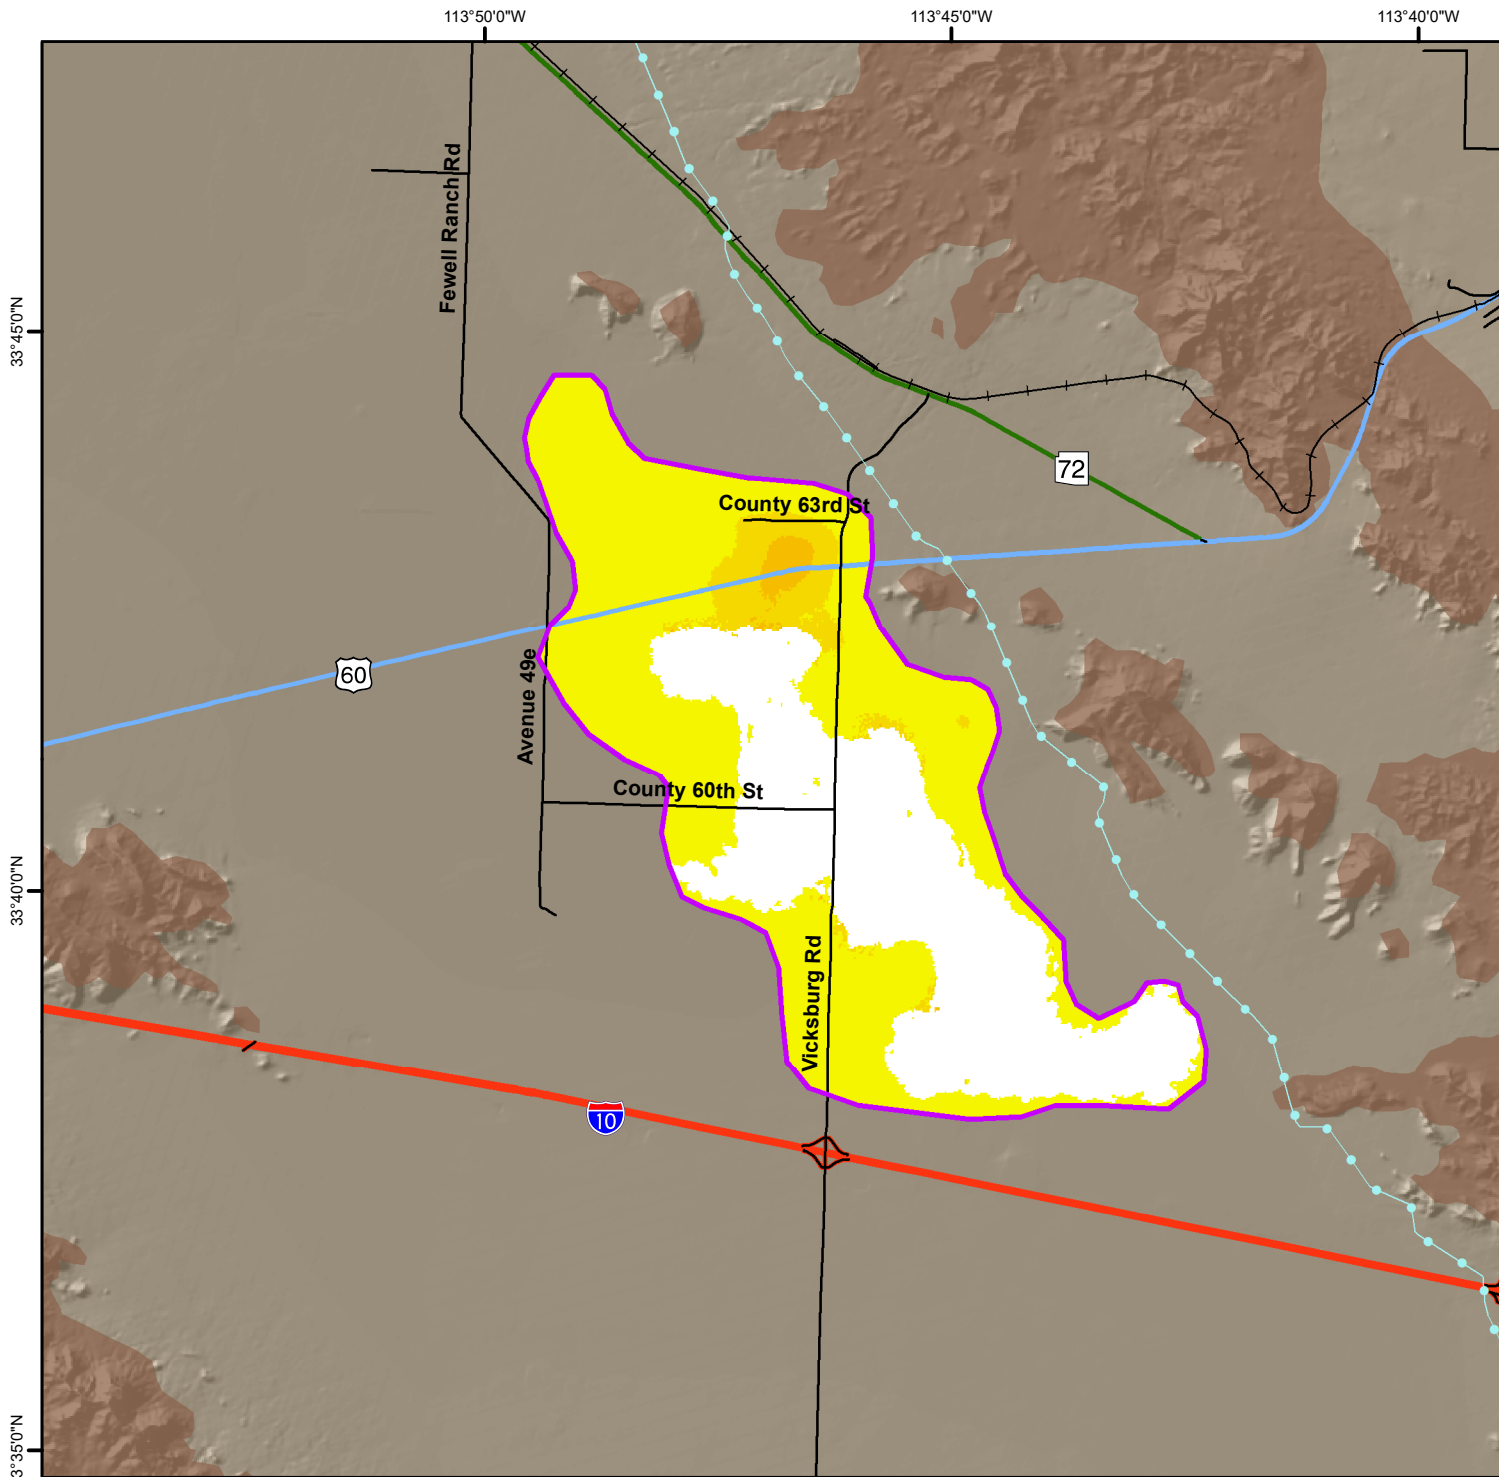
Decorrelation (white areas) are areas where the phase of the received satellite signal changed between satellite passes, causing the data to be unusable. This occurs in areas where the land surface has been disturbed (i.e. bodies of water, snow, agriculture areas, areas of development, etc).
