Total Land Subsidence in the Ranegras Valley, La Paz County
 Based on Radarsat-2 Satellite Interferometric Synthetic Aperture Radar (InSAR) Data
 Time Period of Analysis: 1.0 Years 03/20/2018 To 04/08/2019

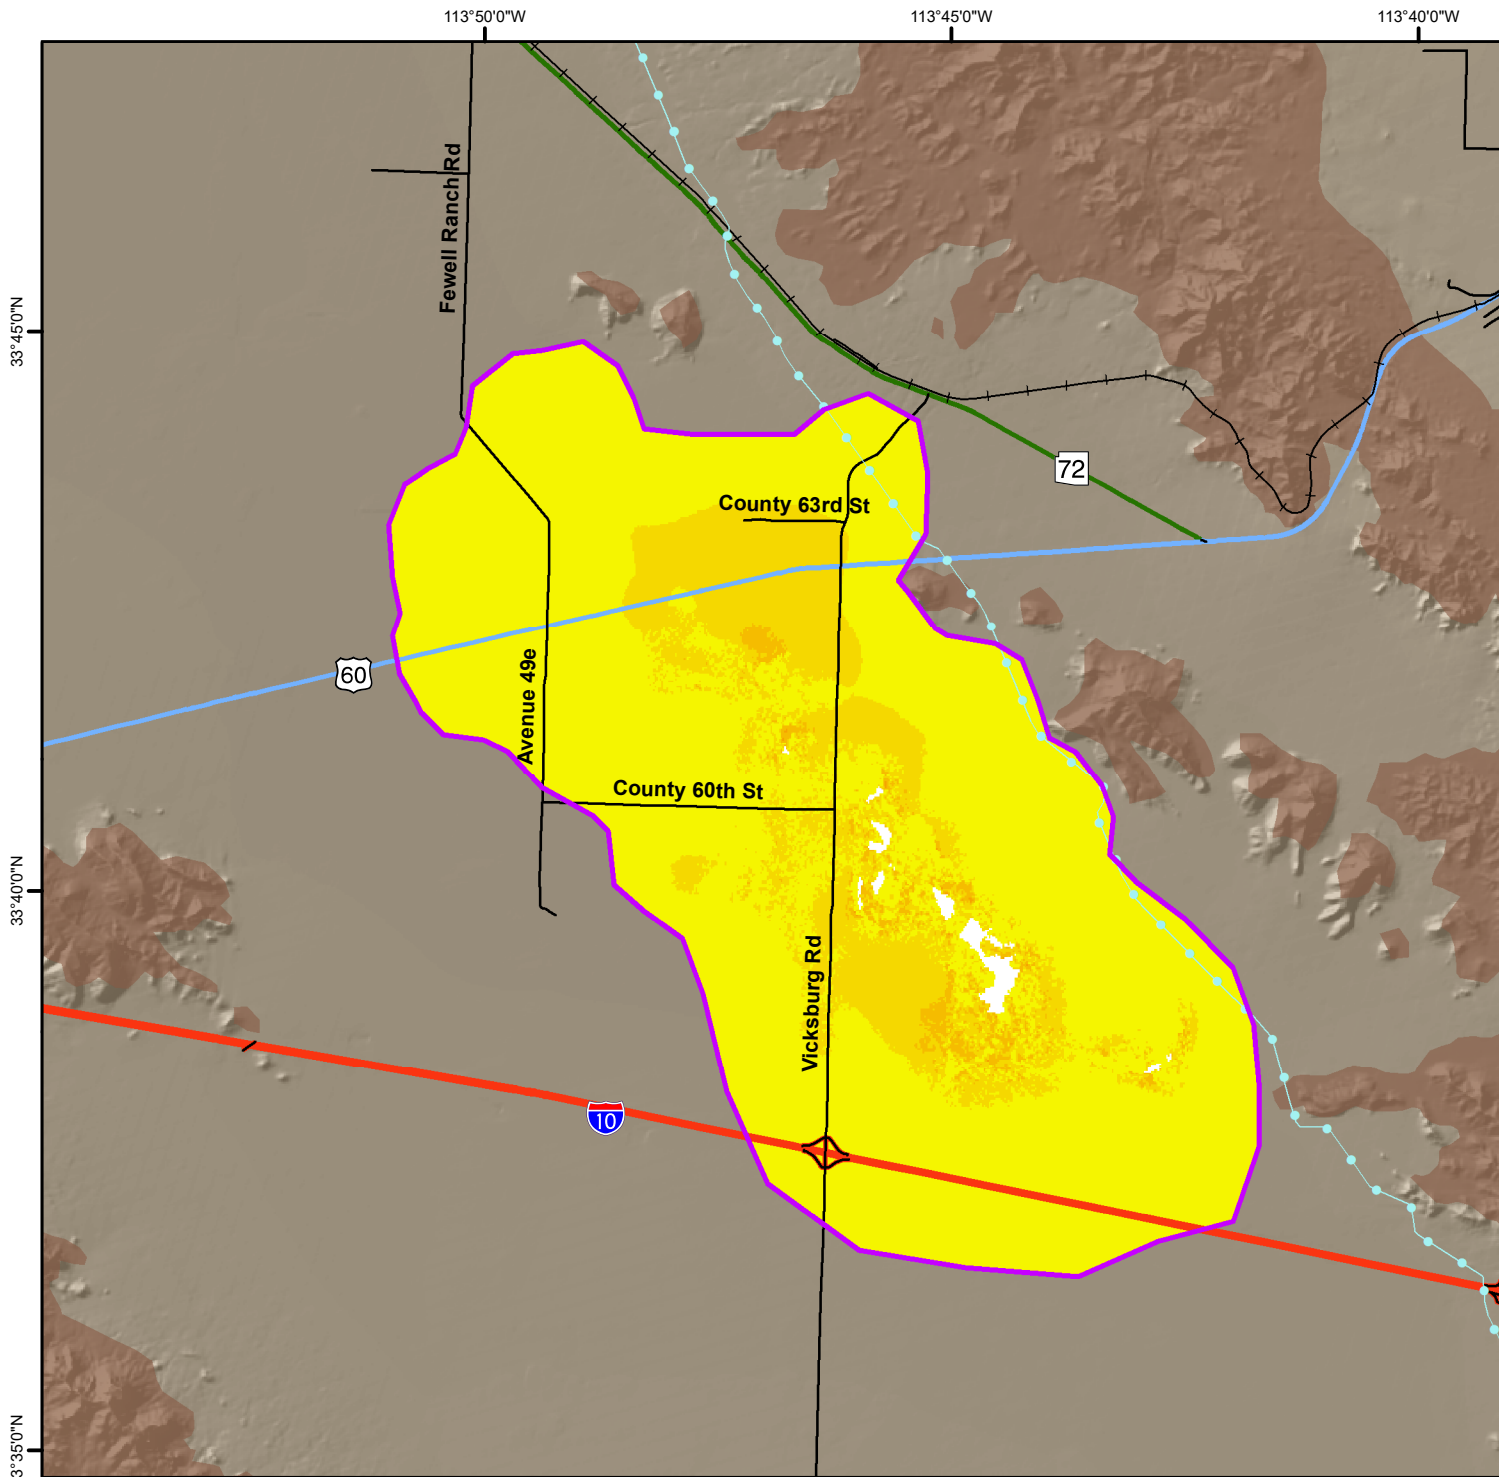
Decorrelation (white areas) are areas where the phase of the received satellite signal changed between satellite passes, causing the data to be unusable. This occurs in areas where the land surface has been disturbed (i.e. bodies of water, snow, agriculture areas, areas of development, etc).
