Historical Land Subsidence in Feet in the Bowie and San Simon Areas, Cochise County
 Based on Holzer, T.L. 1980 USGS Miscellaneous Field Studies Map MF-1156

Time Period of Analysis: 22 Years 1952 To 1974

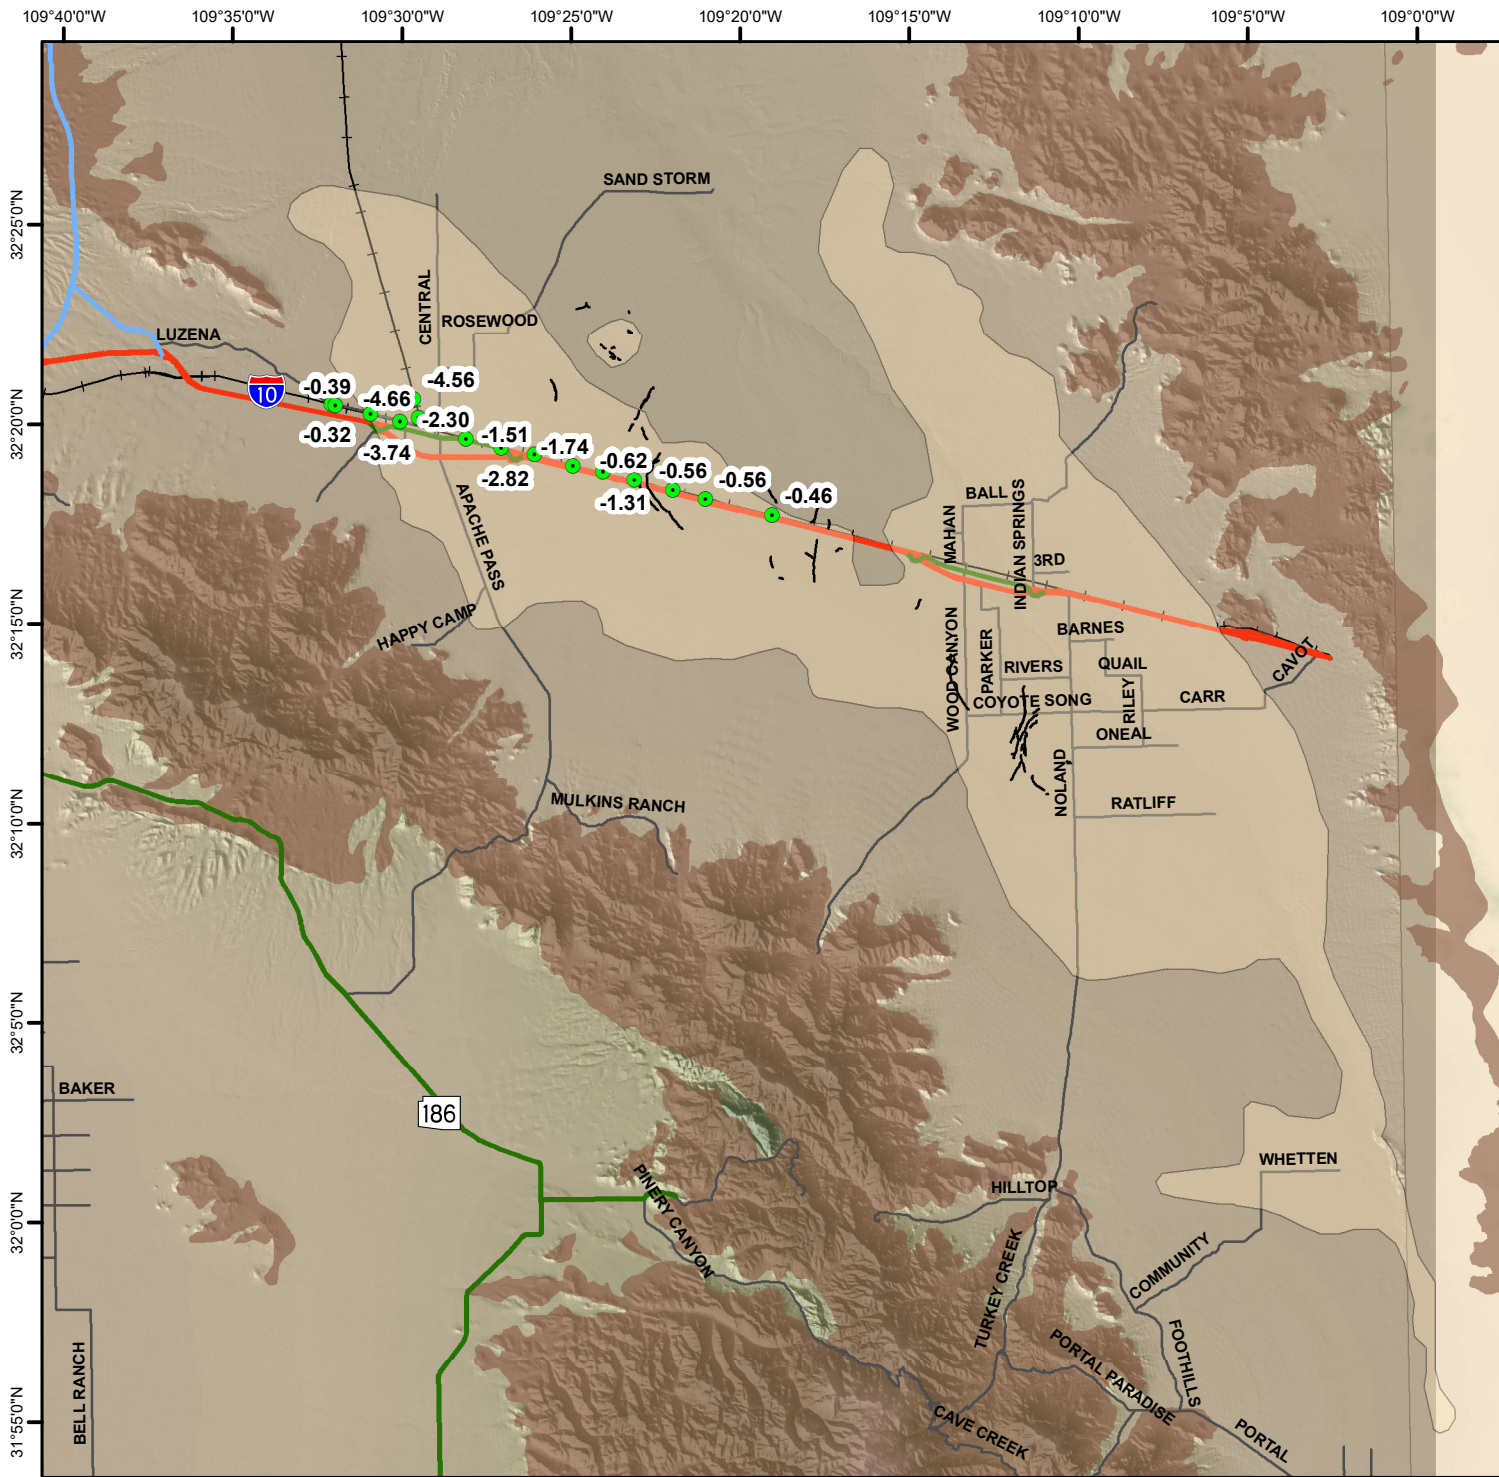
- Historical Subsidence (In feet)
- Subsidence Feature (Based on InSAR)
- Hardrock
- Earth Fissures
- Highways and Interstates**
- Interstate
- US
- State
- Roads
- Railway

Earth fissures were mapped by the Arizona Geological Survey.
 For information on earth fissures visit: www.azgs.az.gov/EFC
