**Land Subsidence Rate in the Holbrook Basin, Navajo County**  
 Based on Radarsat-2 Satellite Interferometric Synthetic Aperture Radar (InSAR) Data  
**Time Period of Analysis: 5.5 Years 09/22/2012 To 04/24/2018**

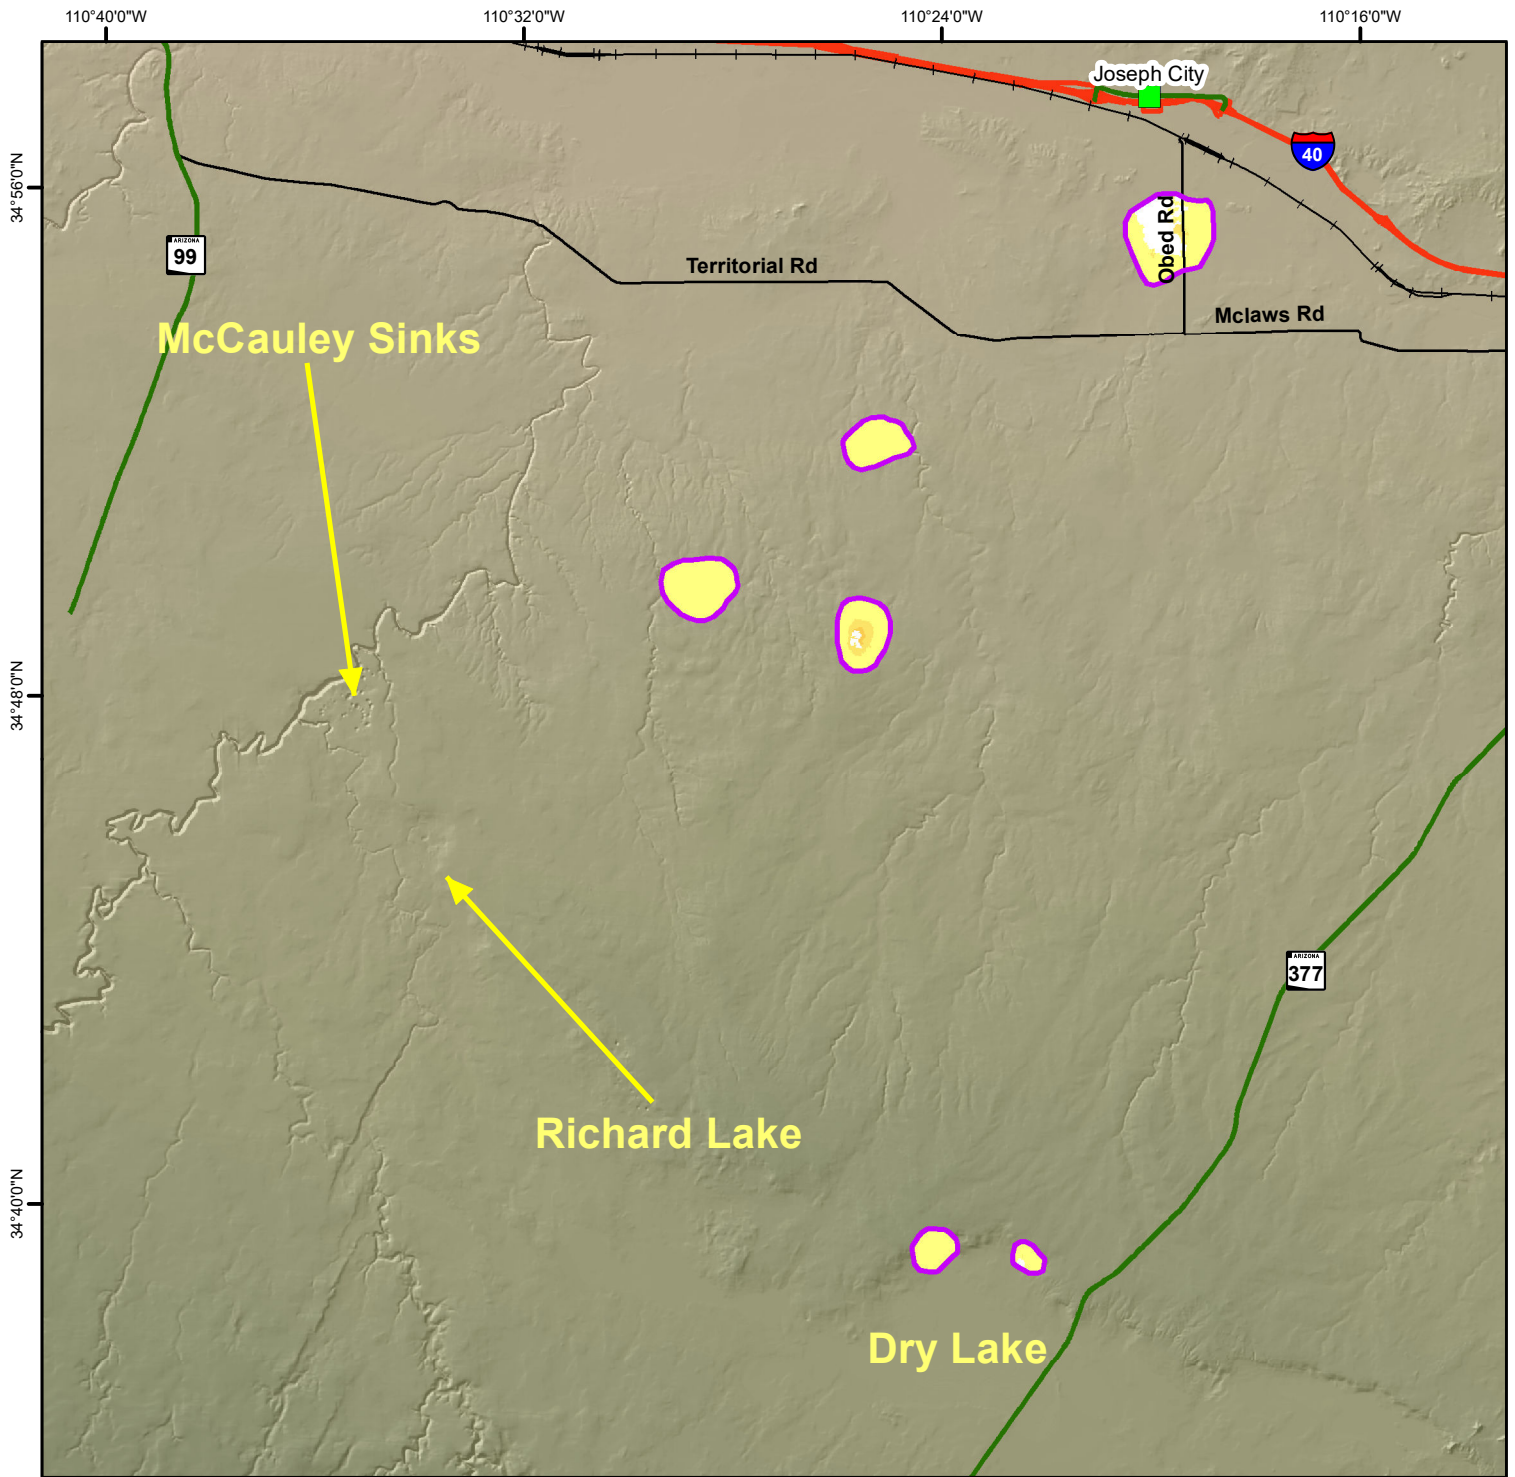
Decorrelation (white areas) are areas where the phase of the received satellite signal changed between satellite passes, causing the data to be unusable. This occurs in areas where the land surface has been disturbed (i.e. bodies of water, snow, agriculture areas, areas of development, etc).
