Land Subsidence Rate in the Ranegras Valley, La Paz County
 Based on Radarsat-2 Satellite Interferometric Synthetic Aperture Radar (InSAR) Data
Time Period of Analysis: 1.0 Years 04/18/2017 To 03/20/2018

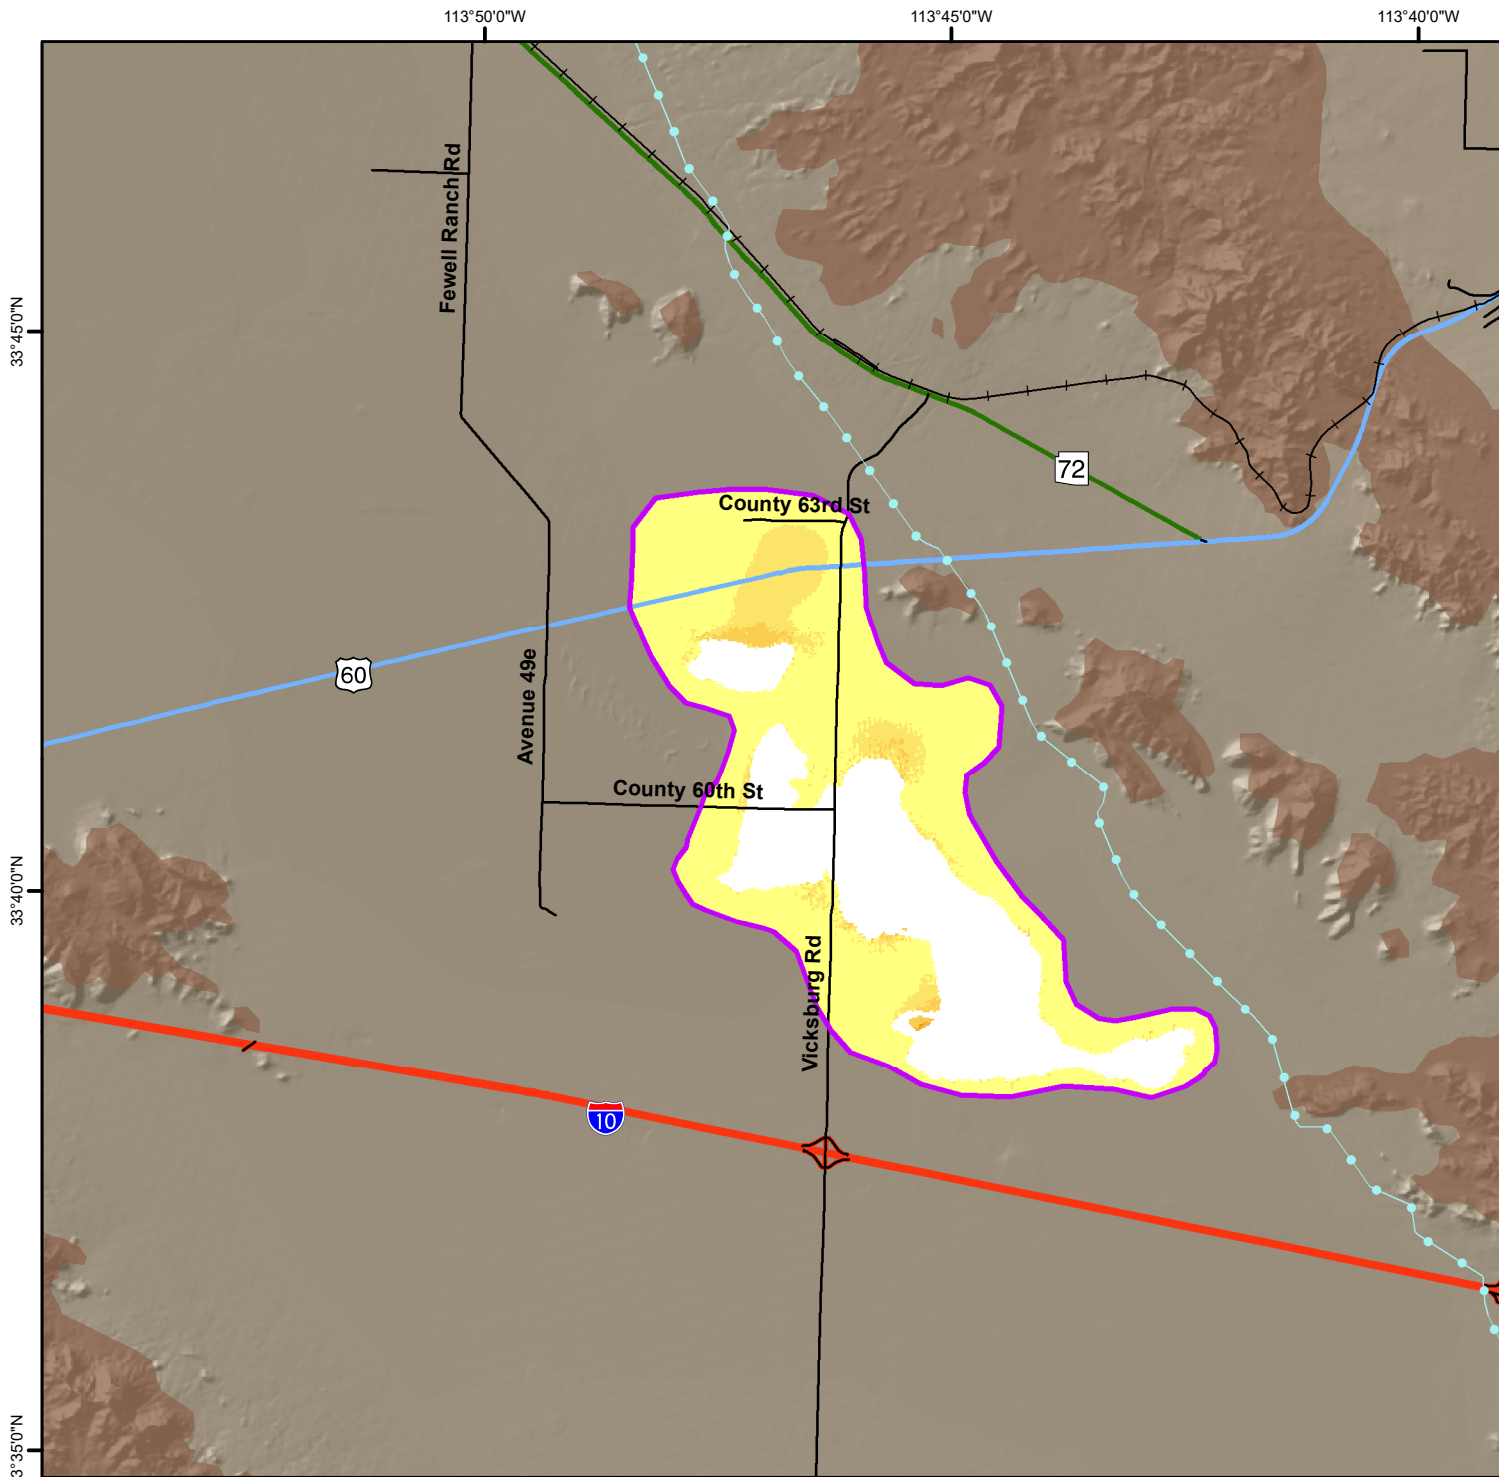
Decorrelation (white areas) are areas where the phase of the received satellite signal changed between satellite passes, causing the data to be unusable. This occurs in areas where the land surface has been disturbed (i.e. bodies of water, snow, agriculture areas, areas of development, etc).
